Cite as: Appl. Phys. Lett. **83**, 4740 (2003); https://doi.org/10.1063/1.1632031 Submitted: 21 July 2003 • Accepted: 16 October 2003 • Published Online: 02 December 2003

High-pressure phase transformation of silicon nitride

John Patten,^{a)} Ronnie Fesperman, and Satya Kumar University of North Carolina at Charlotte, Charlotte, North Carolina 28223

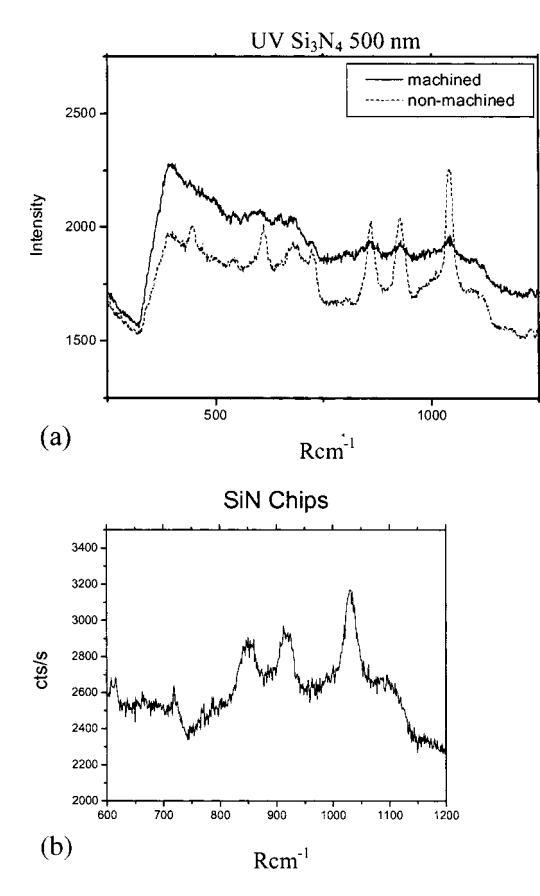
FIG. 1. (a) UV Raman of machined (500 nm depth of cut) and nonmachined Si_3N_4 surface. The broadening in the UV Raman spectra indicates that the machined material near the surface is amorphous; within 0.5 μ m of the surface (UV light does not penetrate the material as deep as visible light and, therefore, allows for analysis of the material's surface of the material). (b) UV Raman of machined Si_3N_4 debris or chips generated by removing 5 μ m of material from the surface of silicon nitride.

UV (wavelength 244 nm) and visible (wavelength 514.5 nm) Raman spectroscopy were used to analyze the structure of micro- and nanomachined Si_3N_4 . The following spectra, presented in Figs. 1(a) and 1(b), represent data collection taken from the surface of machined Si_3N_4 [Fig. 1(a)] and the chips or debris, i.e., removed material that is created during the machining process [Fig. 1(b)]. The Raman spectra, Fig. 1(a) nonmachined surface, exhibits peaks that are a signature for crystalline bulk material; therefore, a phase transformation has occurred at the surface due to the machining process, with the resulting phase being amorphous. The chips also appear to have a higher amorphous phase content as evidenced by the peak broadening, probably a consequence of the extent of the higher compressive stresses generated within the chip.¹⁵

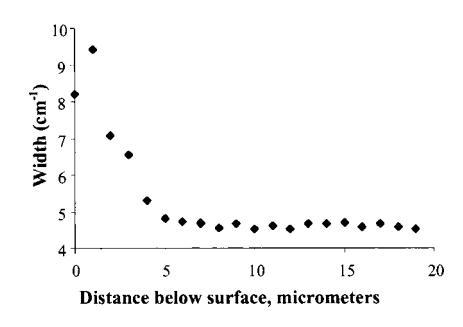
FIG. 2. Micro-Raman results indicating approximately 5 μ m of subsurface damage for a 5 μ m depth of cut on silicon nitride.

terial, which was produced by the ductile or plastic deformation process. The depth of this plastically deformed material layer is 0.5 μ m or less below the surface, for a 250 nm depth of cut. This surface material is believed to consist of the amorphous remnant identified by Raman Spectroscopy. The depth of the damage layer below the surface is proportional to the amount of material removed from the original surface; i.e., a 5 μ m depth of cut resulted in approximately 5 μ m of subsurface damage in the form of an amorphous or plastically deformed layer, as shown in Fig. 2 for a cross section μ -Raman.

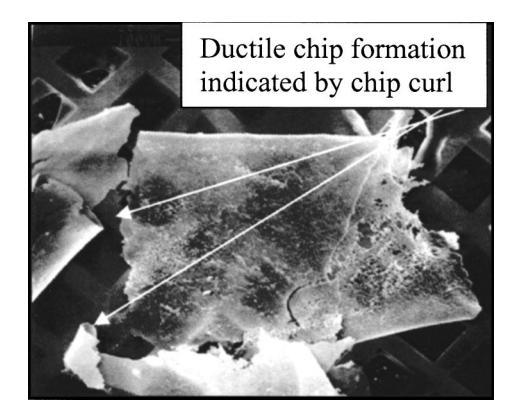
FIG. 3. Scanning electron microscope image of chip/debris from machined Si_3N_4 , area 400 μ m×400 μ m.

Comparable images of the chips or debris generated during processing, shown in Fig. 3, provide clear evidence, that the material deformed in a ductile or plastic manner. The material removed is severely deformed, and the image indicates that the material was able to bend back over upon itself, *without fracture*. The chips are typically quite thin, of the order of a micrometer thick.¹⁷

- ¹⁷Transmission electron microscope (TEM) analysis of these same chips, Fig. 3, indicates a totally amorphous structure with none of the original or starting crystalline phase.
